# Manhole Inspection Summary

Manhole # S35QQ\_042MH

**Location** Address: **101 25TH ST**

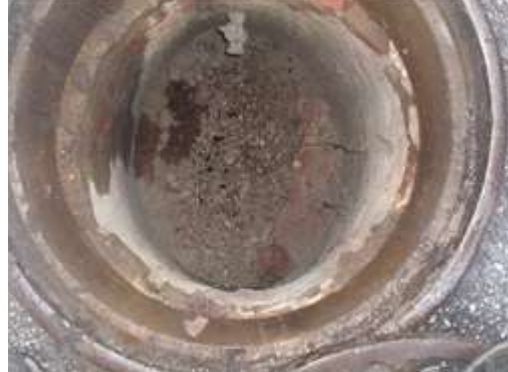
Top View

Channel debris.

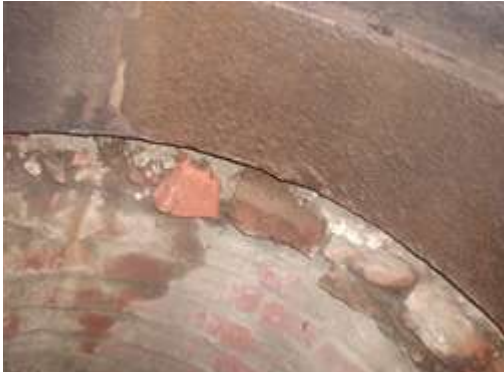
Defect

Frame leaks. Adjustment deterioration, loose bricks and infiltration.

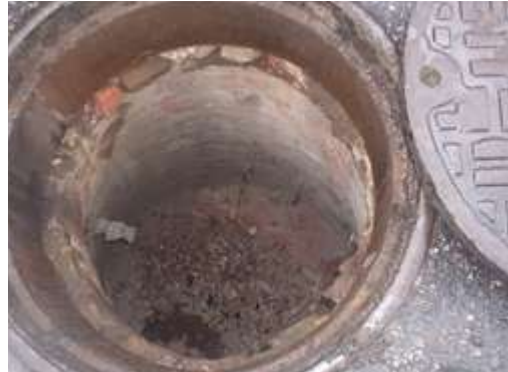
Defect

Frame leaks. Adjustment deterioration, loose bricks and infiltration.

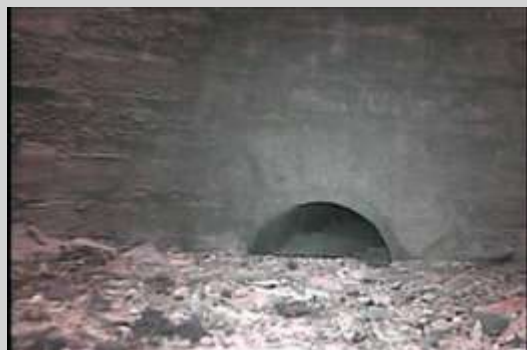
Pipe Out @ 12 O'Clock

Deposits: ☐ None ☒ **Mud** ☐ Sludge ☒ **Debris** ☐ Grease

Silt Depth: **4** (in.)

Deposits Extent: **Medium**
